Mitigations for Jump Conditional Code Erratum

White Paper

Revision 1.0 November 2019

Document Number: 341810-001

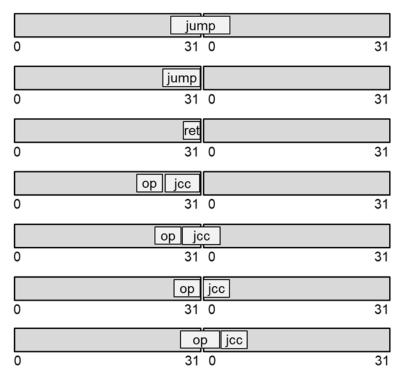
Figure 1: Jumps and 32-byte boundary

This erratum can be prevented by a microcode update (MCU). The MCU prevents jump instructions from being cached in the Decoded ICache when the jump instructions cross a 32-byte boundary or when they end on a 32-byte boundary. In this context, *Jump Instructions* include all jump types: conditional jump (Jcc), macrofused op-Jcc (where op is one of cmp, test, add, sub, and, inc, or dec), direct unconditional jump, indirect jump, direct/indirect call, and return.
