# Intel<sup>®</sup> Xeon<sup>®</sup> Processor E5 Product Family

**Specification Update**

*February 2017*

*Revision 020*

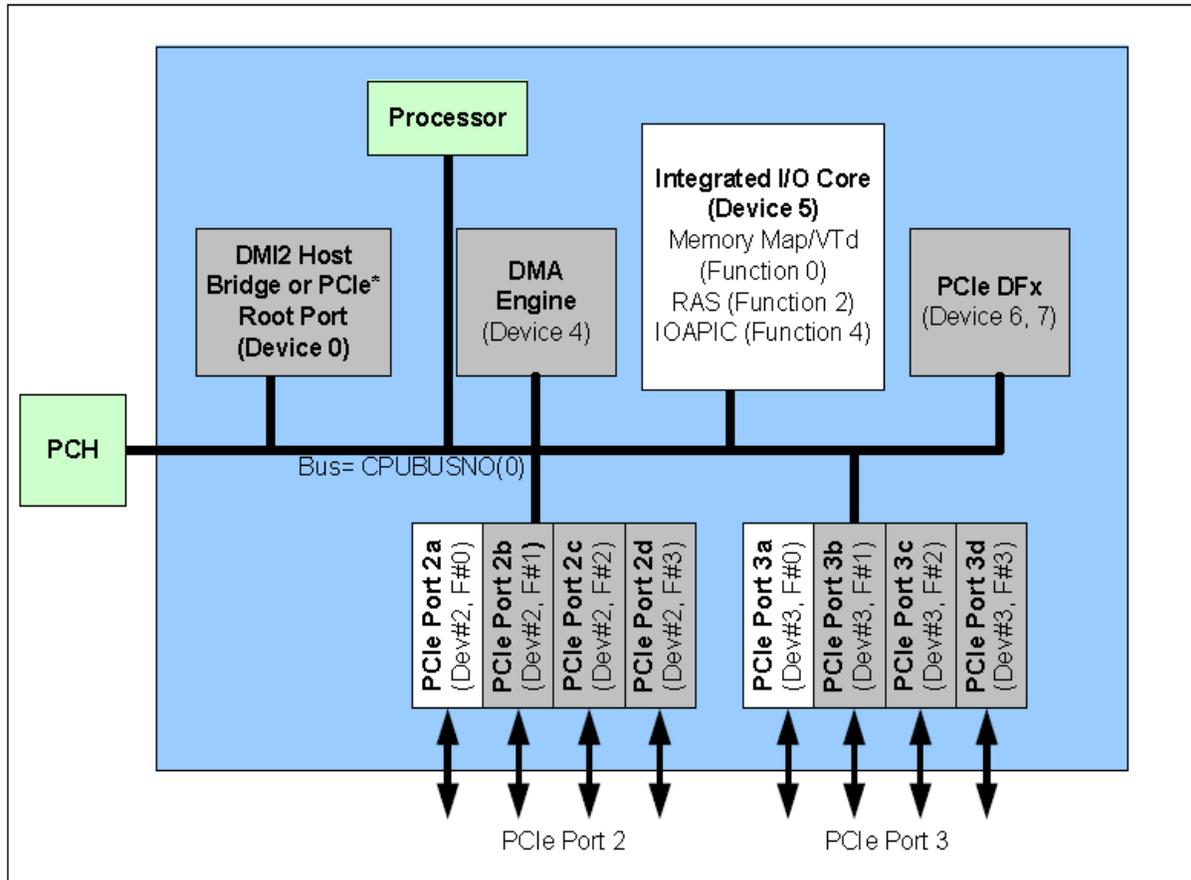
The drawing in the current document does not include devices 6 and 7. These are internal devices not generally accessible on production systems. The drawing below is correct.

Device 6, 7: PCI Express Dfx. Contains the PCI Express debug (DFx), Lock, Error Inject Registers.
